NONDESTRUCTIVE EVALUATION OF METAL MATRIX COMPOSITES.(U)

MAY 82 S W SCHRAMM, I M DANIEL

NONDESTRUCTIVE EVALUATION OF METAL MATRIX COMPOSITES

FINAL REPORT

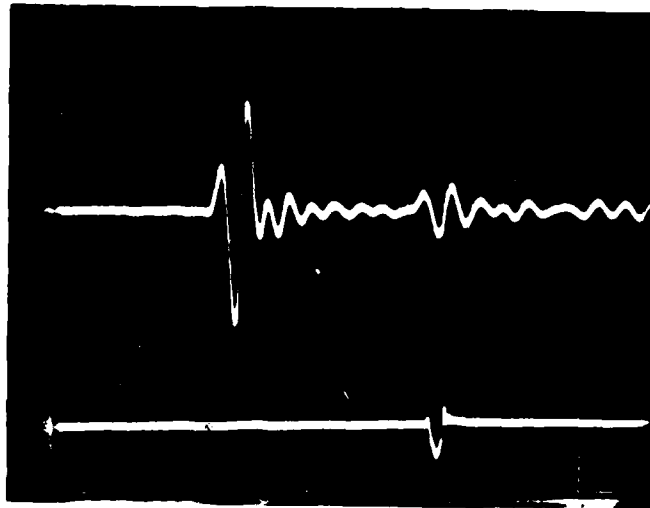
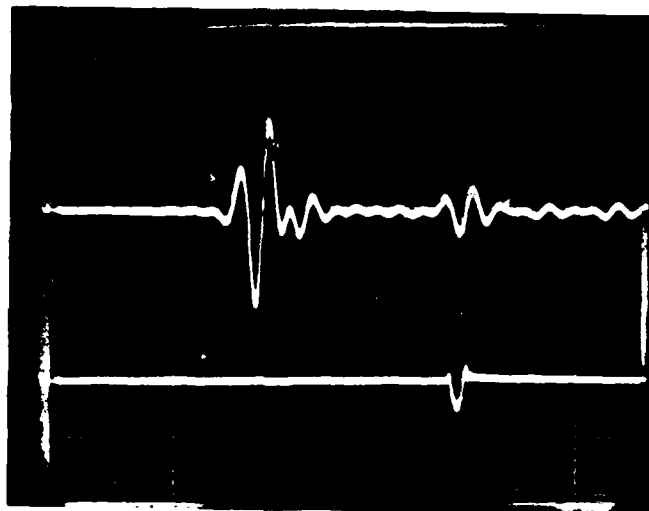
The areas of "apparent flaws" were determined to be either surface irregularities or excess amounts of sealant which extruded onto the front face of the specimen. This determination was made by visual inspection and by interpretation of A-scan photographs taken at the areas of "apparent flaws." Figure 22 shows characteristic A-scans at an "apparently unflawed and flawed" location on Specimen 1-1.

The key to interpreting the two A-scans in Figure 22 is the relative shape and size of the front and back-face reflections. The difference between the A-scan at the "unflawed location (Figure 22a) and at the "flawed" location (Figure 22b) is a decrease in the amplitude of the front-face reflection of the waveform. This is an indication of a minor irregularity at the front-face of the specimen. In this instance an air bubble was attached to the front-face of Specimen 1-1. Similar A-scans were generated where surface irregularities (such as scratches) or excess sealant were present. Figure 23, a pen-lift C-scan of Specimen 1-1, which was generated using a 5 MHz, immersion, compression wave transducer operated in the pulse-echo mode, gives a better overall representation of the material integrity for this particular specimen, but is less sensitive to the presence of defects than the C-scans shown in Figures 20 and 21. This exemplifies the fact that the C-scan only indicates the presence of a defect, and provides limited information about the type or severity of a defect.

Figure 22. Amplitude-time records (A-scans) of ultrasonic pulse at two locations of Specimen 1-1. (a) Unflawed location, (b) flawed location. (0.5 V/div, 0.5 μ sec/div) 15 MHz transducer in pulse-echo mode.

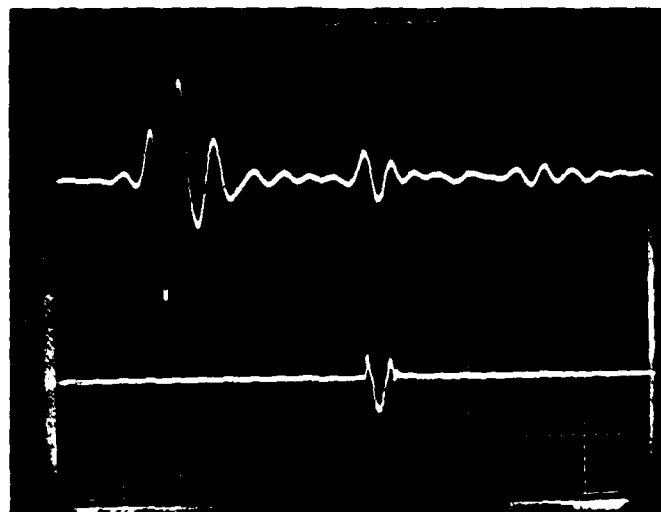
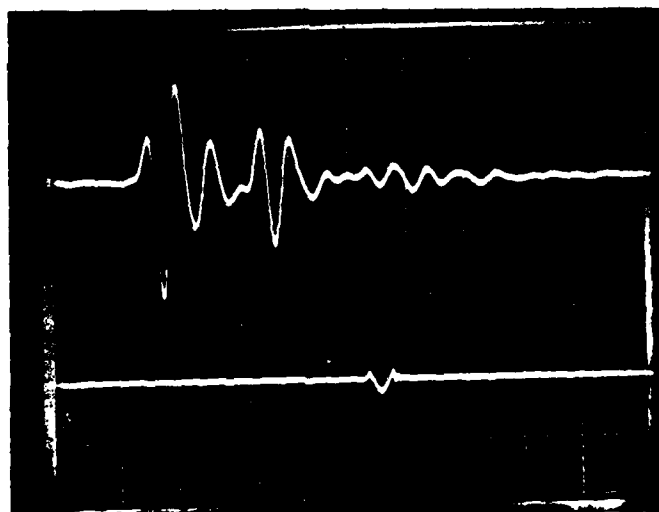
For Specimen 2-1, ultrasonic inspection, pen-lift/analog C-scan, and A-scan photographs gave a representative indication of the presence of a delamination near the mid-thickness of the specimen. Visual inspection of Specimen 2-1 confirmed the presence of the delamination since the defect was open to the free surface on the lower edge. Subsequent discussions with DuPont personnel, reported in the ninth monthly progress report (IITRI-M06084-9), indicated that the Type 2 specimens were fabricated with delaminations instead of fiber-matrix debonding.

Figure 31. Amplitude-time records (A-scans) of ultrasonic pulse at two locations of Specimen 2-1 (fiber-matrix debonding). (a) Unflawed location, (b) flawed location. (0.5 V/div, 0.5 μ s/div.) 15 MHz transducer in pulse-echo mode.

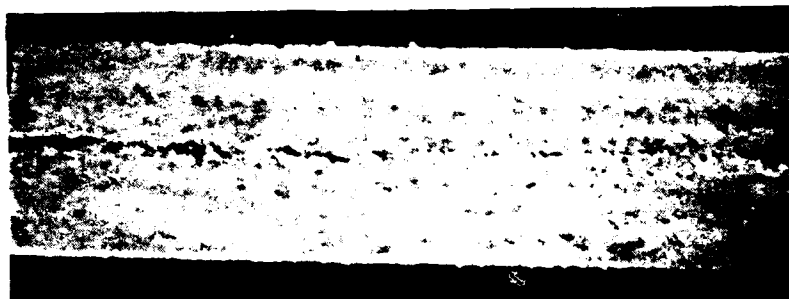
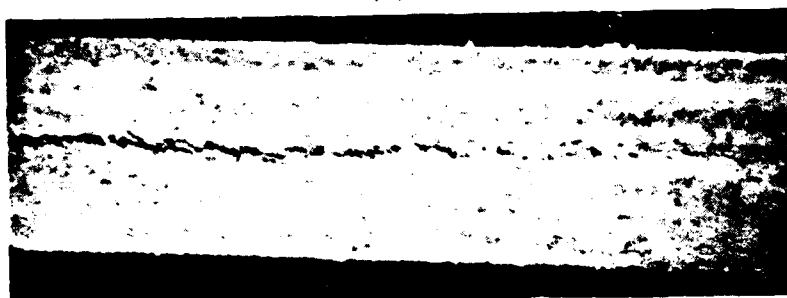
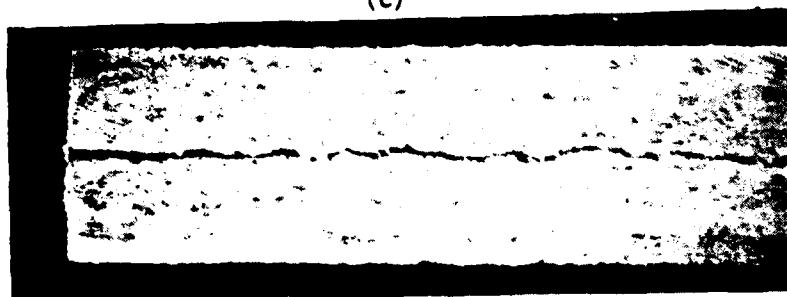
Figure 34. Micrographs (5X) of FP/Mg Specimen 2-1 (fiber-matrix debonding) at four section locations: (a) Location 2-1-1, (b) Location 2-1-2, (c) Location 2-1-3, and (d) Location 2-1-4.

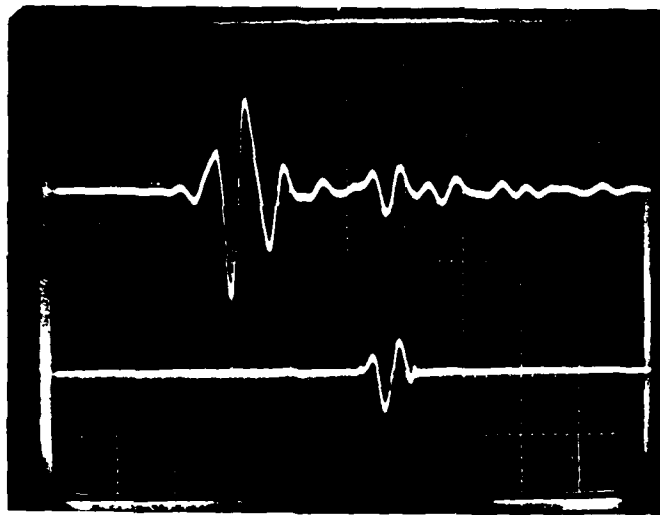
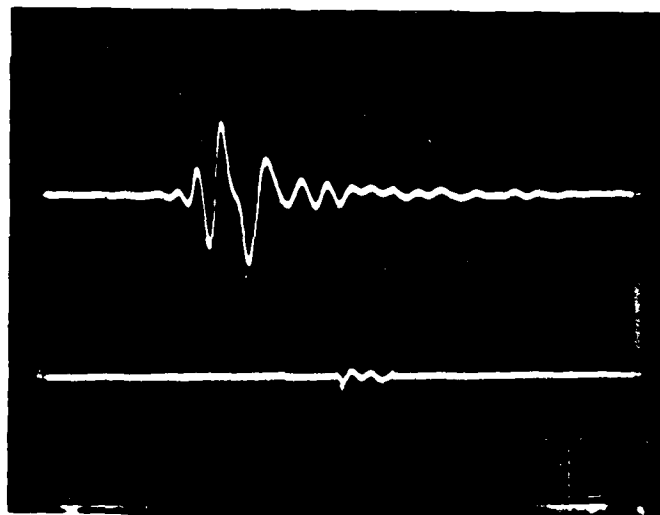
Figure 38 shows an A-scan photograph of Specimen 3-1 at an unflawed, and a flawed location, respectively. The A-scan photograph of the flawed location (Figure 38b) was taken at inspection location 3-1-3 as indicated on Figure 36.

Figure 38. Amplitude-time records (A-scans) of ultrasonic pulse at two locations of Specimen 3-1 (porosity). (a) Unflawed location, (b) flawed location. (0.5 V/div, 0.5 μ s/div.) 15 MHz transducer in pulse-echo mode.

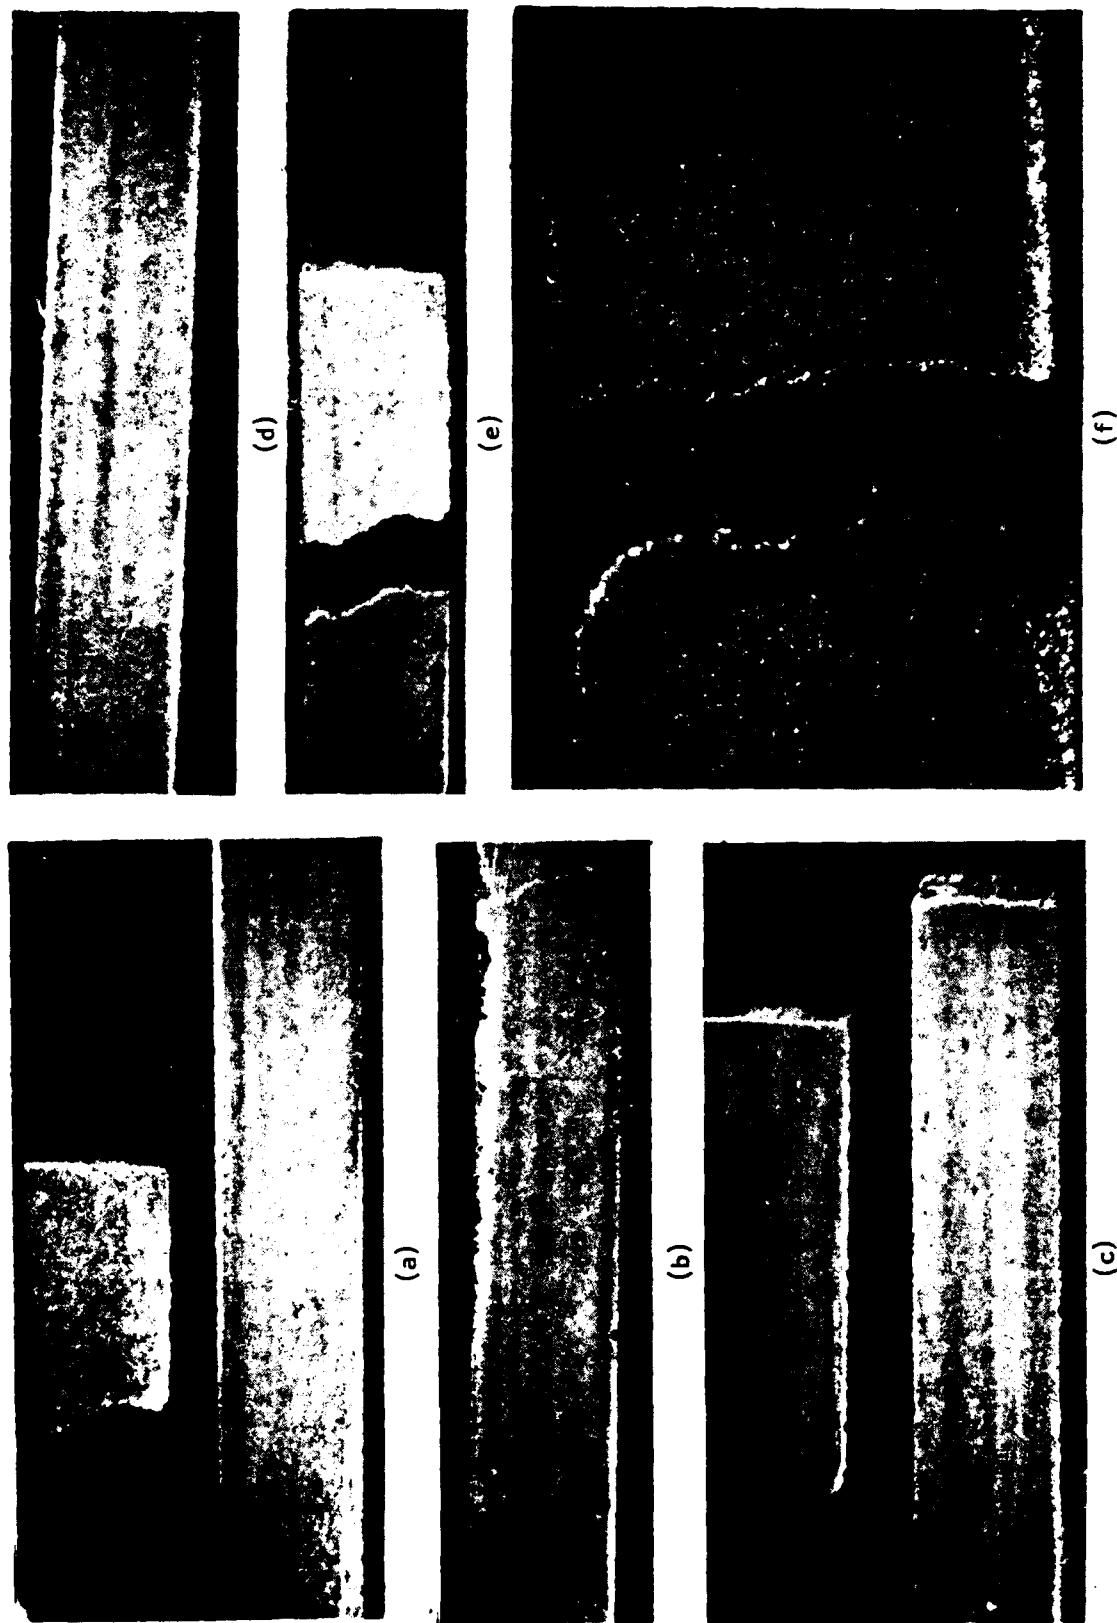
The lower power micrographs, Figure 41, proved to be very disappointing in that the area of apparent porosity indicated in the C-scans did not appear as a gross material defect. At the 200X magnification level, apparent pores can be seen, especially in Figures 42a and 42b, as highlighted by the arrows. The pores appear as dark regions void of matrix material, but where fiber ends can be seen. The large dark areas on Figures 42a, 42c, and 42d are fracture or free edge surfaces of the respective sections. The viewing area of the 200X micrograph is very limited and does not show the distribution of the porosity. In general, there was no pattern to the pore distribution. The pores were essentially uniformly distributed throughout the cross-sections.

Figure 41. Micrographs of FP/Mg Specimen 3-1 (porosity) at four section locations: At 5X, (a) Location 3-1-1, (b) Location 3-1-2, (c) Location 3-1-3, (d) Location 3-1-1, (e) Location 3-1-4, (f) Location 3-1-3.

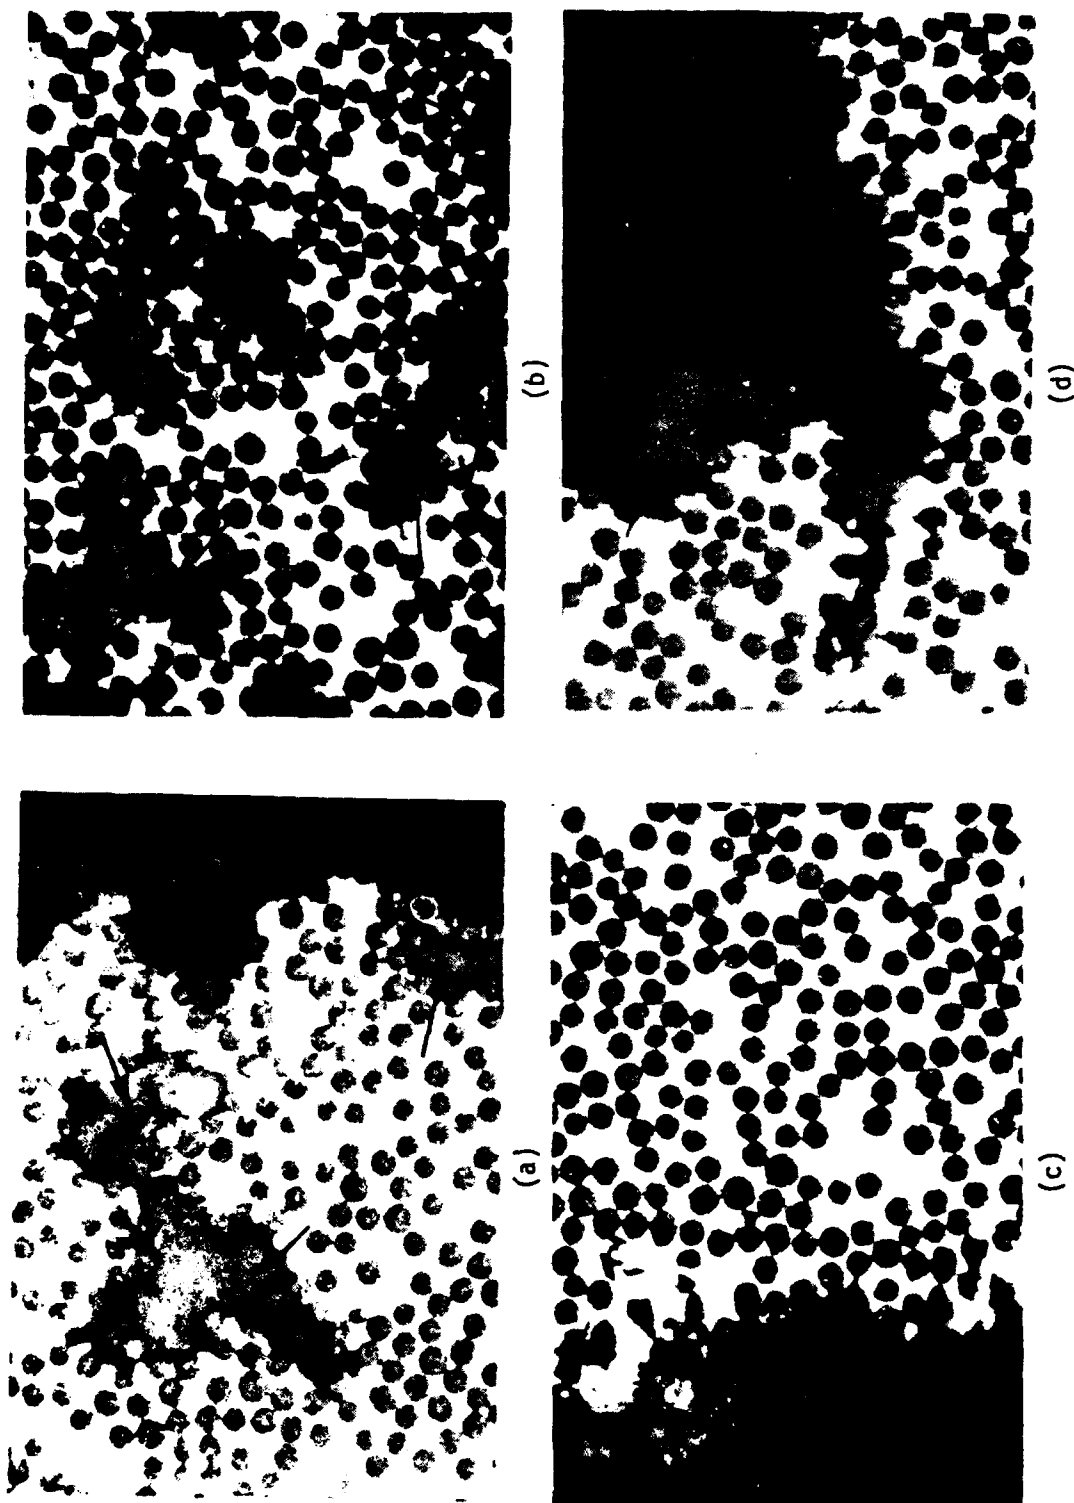
Figure 42. Micrographs (200X) of FP/Mg Specimen 3-1 (porosity) at four section locations:
 (a) Location 3-1-1, (b) Location 3-1-2, (c) Location 3-1-3, and (d) Location 3-1-4.

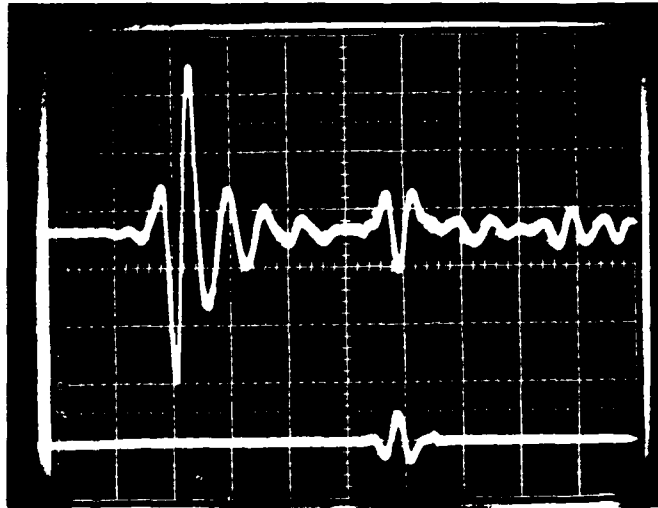
Figure 45. Amplitude-time record (A-scan) of ultrasonic pulse at an unflawed location of Specimen 4-1 (fiber misalignment). (0.2 V/div, 10 μ s/div.) 15 MHz transducer in pulse-echo mode.

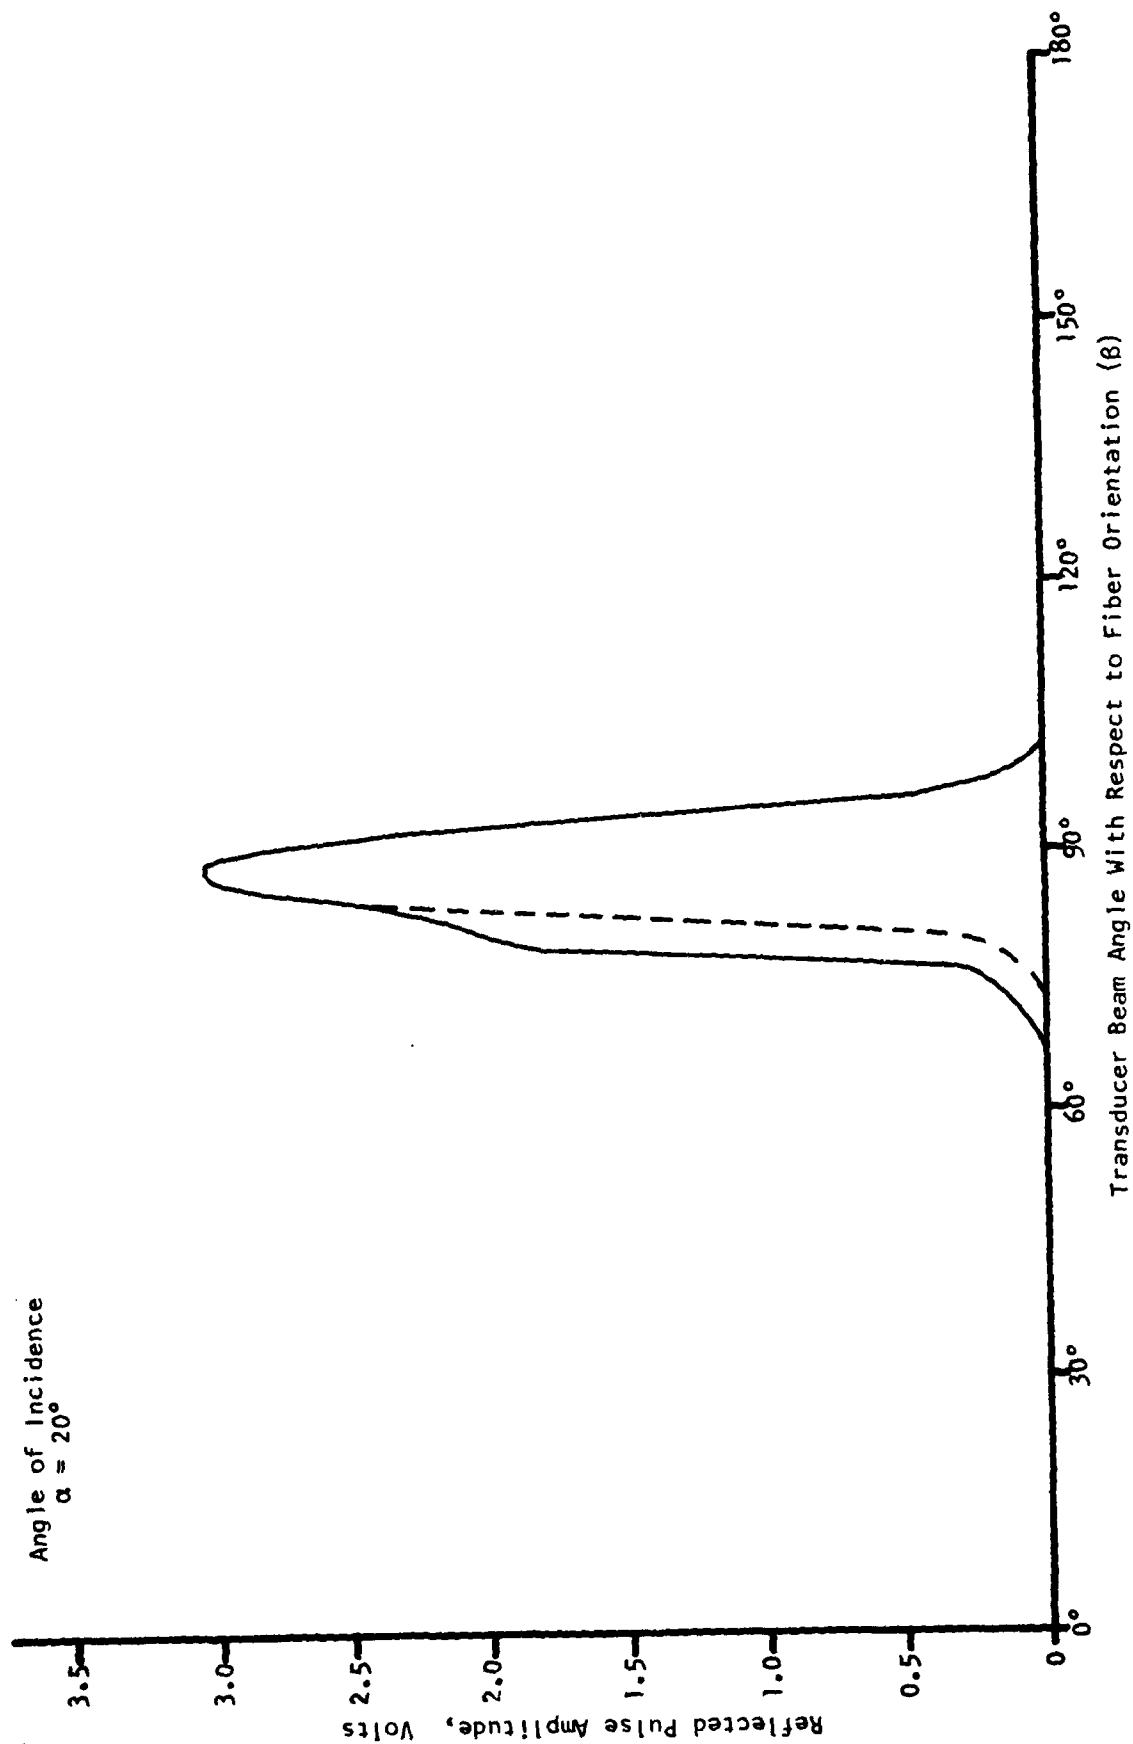
Figure 47. Ultrasonic backscattering curve of FP/Mg specimen with fiber misalignment (Specimen 4-1).

Of the NDE procedures used to evaluate Specimen 4-1, only ultrasonic backscattering indicated the presence of fiber misalignment. Because of the nature of the flaw, there was little or no abnormal material attenuation; and since the other ultrasonic techniques rely upon material attenuation as the defect indicating mechanism, they could not discern the presence of the fiber misalignment. All of the NDE procedures were consistent in that they all showed the specimen to have uniform material integrity.

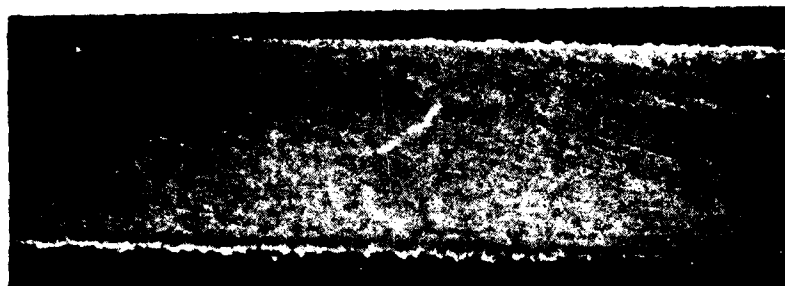
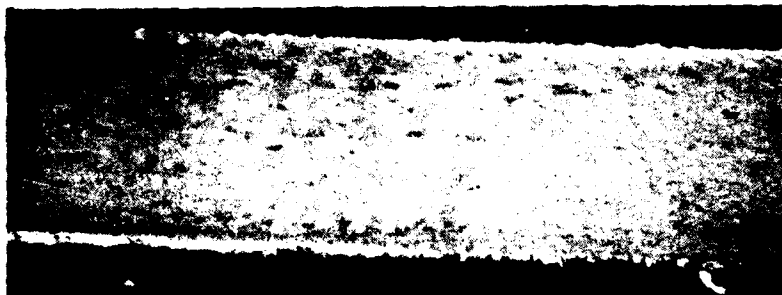
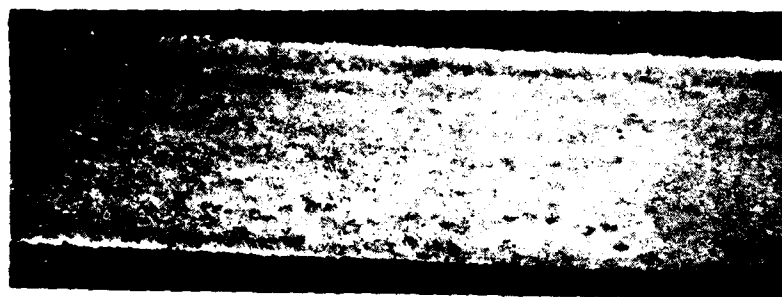
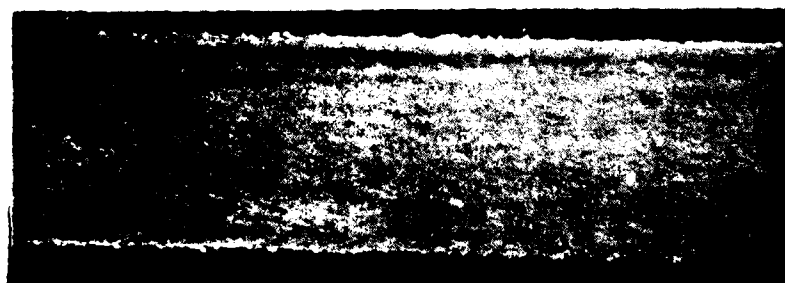
The micrographs do not show, and were not expected to show, the two plies of misaligned fibers. This was because the degree angle of the misalignment is so slight that it barely affected the shape of the exposed fibers. Normally, off-axis fibers can be distinguished because they have an elliptical cross section when viewed along the fiber axis. This can be seen for one fiber bundle each in Figures 49a and 49d (highlighted by arrows), respectively. In

Figure 48. Micrographs (5X) of FP/Mg Specimen 4-1 (fiber misalignment) at four section locations: (a) Location 4-1-1, (b) Location 4-1-2, (c) Location 4-1-3, and (d) Location 4-1-4.

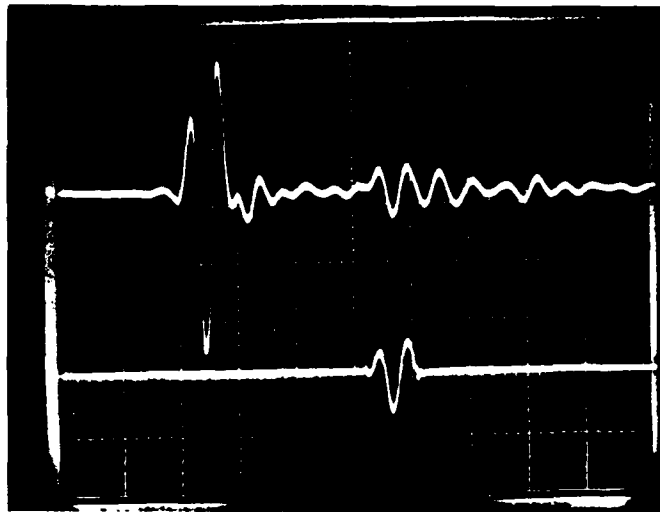
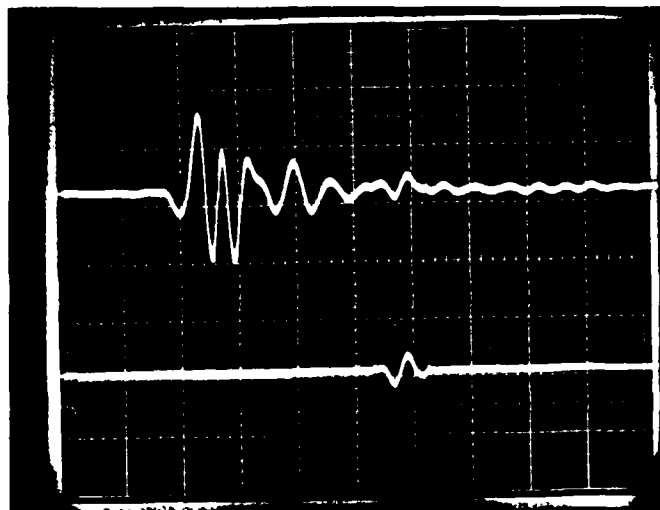
Figure 52 shows a typical A-scan photograph of Specimen 5-1 at an unflawed (Figure 52a) and a flawed (Figure 52b) location, respectively. Figure 52a corresponds to inspection location 5-1-2 of Figure 51, and Figure 52b corresponds to inspection location 5-1-4 of Figure 51. Figure 52a is a characteristic waveform for apparently undamaged material in that it has a well-defined front and back-face reflection similar to that shown in Figure 22a for Specimen 1-1 (no intentional flaws). Figure 52b clearly indicates an area of apparent damage by the misshaping of the front-face reflection, the formation of a mid-thickness pulse similar to that shown in Figure 31b for Specimen 2-1 (fiber-matrix debonding/delamination), and the near total disappearance of the back-face reflection. Figure 52b indicates the presence of a highly attenuative defect which has a reflective surface associated with it. This is very similar to the waveform generated from Specimen 3-1 (porosity) shown in Figure 38b. The reduction of the amplitude of the front-face reflection indicates that the apparent fiber fracture involved the material plies adjacent to the front surface of the specimen as seen by the transmitting/receiving transducer. The mid-thickness pulse indicates the presence of a reflective surface. This could be expected since the fiber fracture was manufactured and the number of plies which had the fractures were closely controlled. This means that there would be an obvious demarcation between the plies with or without fiber fracture. The fact that the back-face reflection can be clearly identified, albeit at a lower amplitude than for the unflawed location, indicates that the attenuative effect of the apparent fiber fracture was not as great as that of porosity where the back-face reflection virtually disappeared.

Figure 52. Amplitude-time records (A-scans) of ultrasonic pulses at two locations of Specimen 5-1 (fiber fracture). (a) Unflawed location, (b) flawed location. (0.5 V/div, 0.5 μ s/div.) 15 MHz transducer in pulse-echo mode.

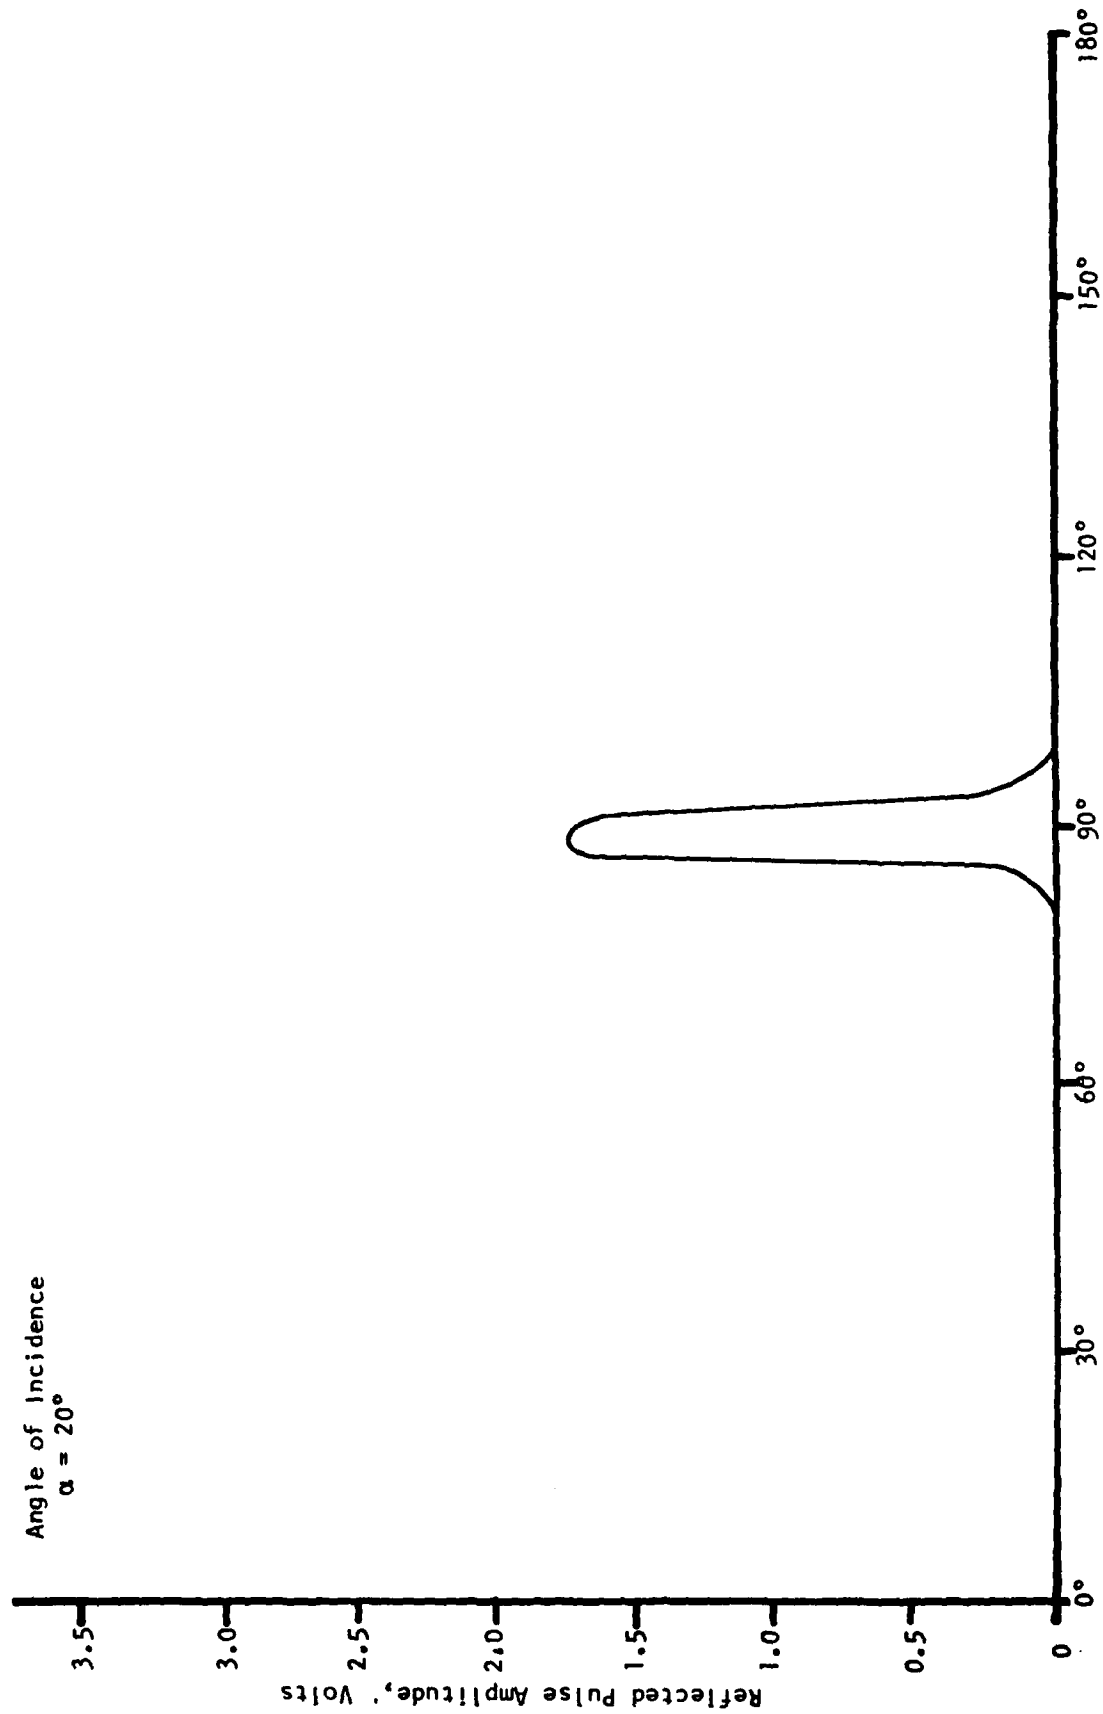
This curve gives no indication of the presence of fiber fracture beyond the decrease of the amplitude of the reflected pulse. The only activity on the curve occurs when the transducer focal axis sweeps near and through the plane normal to the fiber orientation.

For Specimen 5-1, ultrasonic backscattering does not appear to give any appreciable indication of the presence of fiber fracture.

Figure 54. Ultrasonic backscattering curve of FP/Mg specimen with fiber fracture (Specimen 5-1).

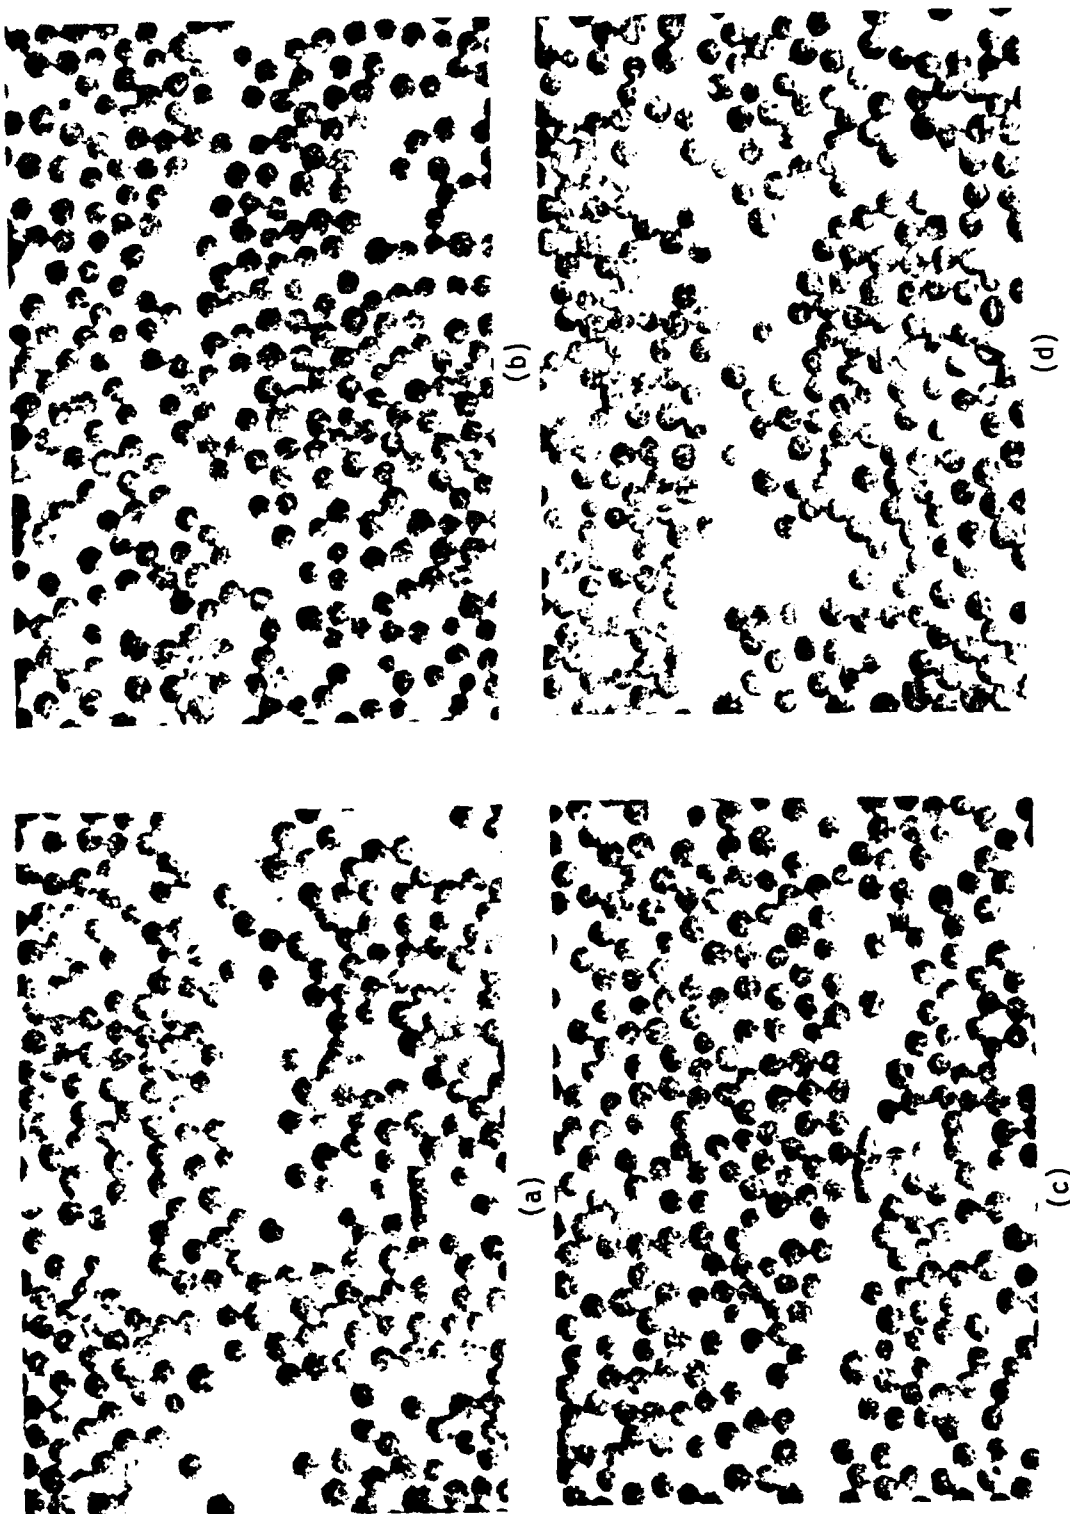
With the exception of section 5-1-2, Figures 55b and 55e, these micrographs show no indications of the presence of any gross material defects. A possible explanation for this is that the defect (i.e., the broken fibers) is in the same plane as the section inspection surface. This means there is no perspective angle available where the defect can be compared against a uniform material background. The defect could be exposed if the section were cut in a plane parallel to the fibers. This is very difficult to execute since the section cut has to be made slightly above the ply interface where the damaged fibers are located. Compounding the problem is that most separating blades

Figure 56. Micrographs (200X) of FP/Mg Specimen 5-1 (fiber fracture) at four section locations: (a) Location 5-1-1, (b) Location 5-1-2, (c) Location 5-1-3, and (d) Location 5-1-4.

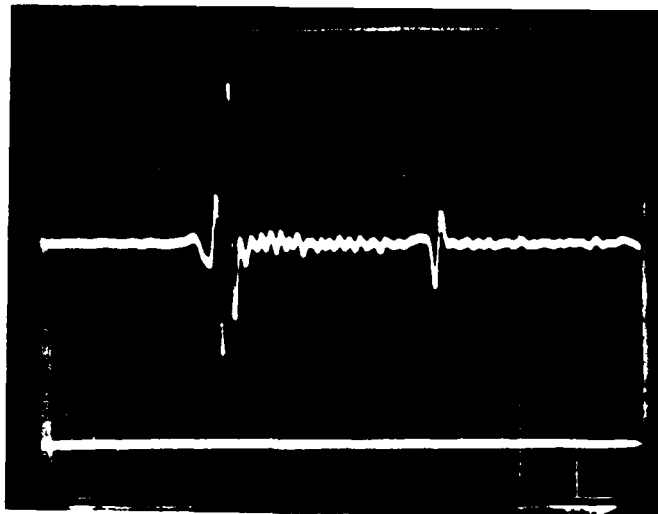
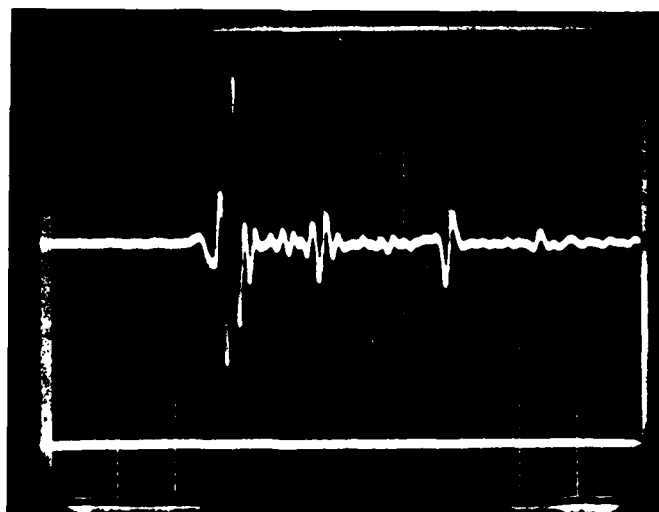
Figure 59b is an interesting version of an A-scan indicating a mid-thickness reflective surface, similar to the A-scans for Specimen 2-1 (fiber matrix debonding/delamination, see Figure 31b) and for Specimen 5-1 (fiber fracture, see Figure 52b). In Figure 59b, unlike Figures 31b and 52b, the presence of the mid-thickness pulse did not decrease the amplitude of either the front or back-face reflection from the specimen. The explanation for this phenomenon requires an understanding of how the area of nonuniform fiber distribution was

Figure 59. Amplitude-time records (A-scans) of ultrasonic pulse at two locations of Specimen 6-2 (nonuniform fiber distribution). (a) Unflawed location, (b) flawed location. (0.5 V/div, 0.5 μ s/div.) 15 MHz transducer in pulse-echo mode.

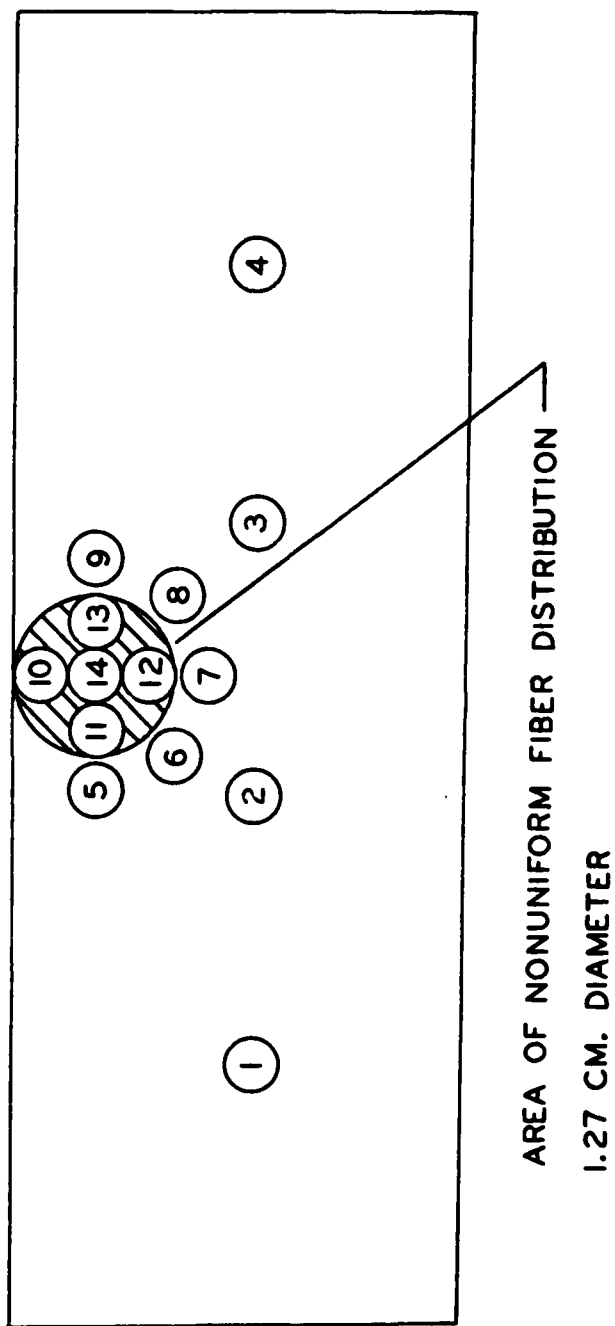
Figure 60 shows the inspection locations on Specimen 6-2 where wave propagation velocity measurements were taken. Table 12 shows the wave propagation velocities for the 14 inspection locations shown in Figure 60, and the average wave propagation velocity of the first nine measurements. The average wave propagation velocity for Specimen 6-2 (for the unflawed locations) is within 6% of the theoretical value of 6119 ms^{-1} for Specimen 6-2 and within 1% of the empirical average of 6466 ms^{-1} for Specimen 1-1. As a comparison, the average wave propagation velocity for the 20 inspection locations shown in Figure 24 for Specimen 6-2 was 6466 ms^{-1} which is identical to the empirical average for Specimen 1-1.

Figure 60. Wave propagation velocity inspection locations for FP/Mg Specimen 6-2 (nonuniform fiber distribution).

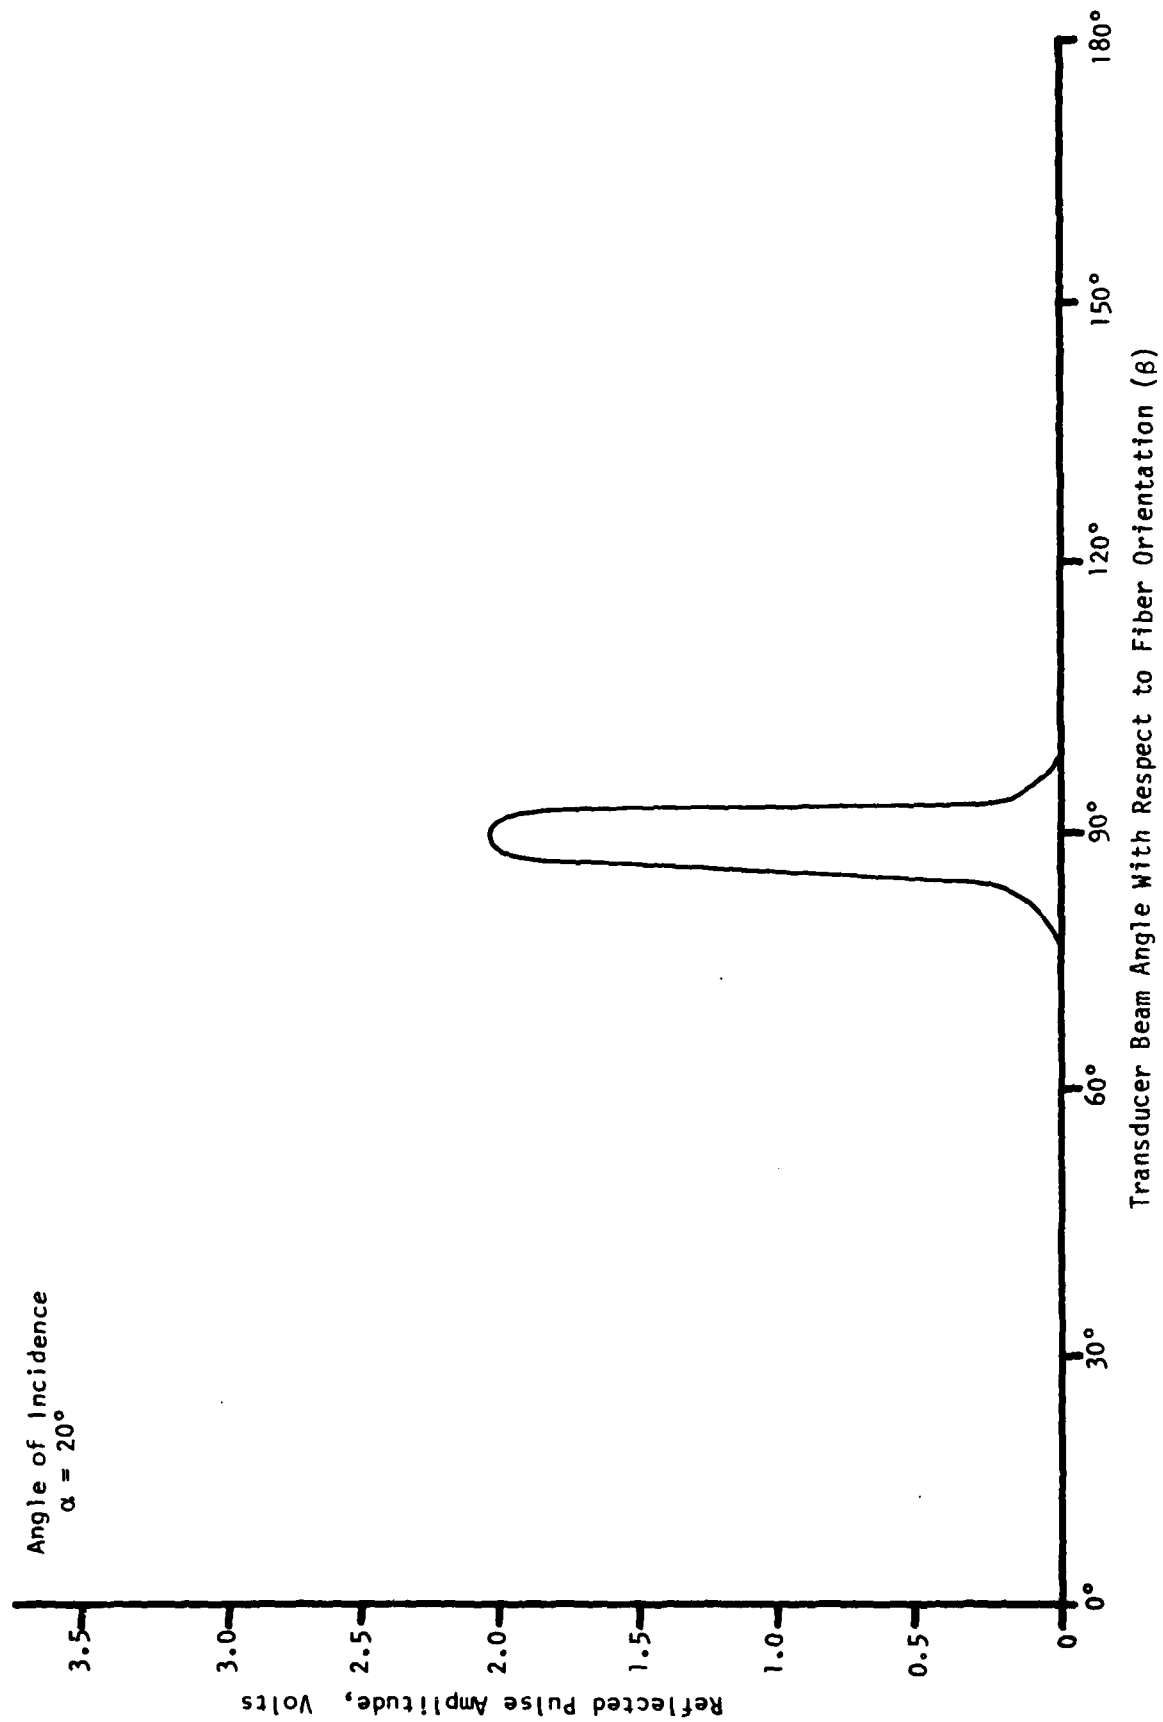
Figure 62 is a backscatter curve of Specimen 6-2. The incident angle (α) of the 5 MHz immersion transducer operated in the pulse-echo mode was 20° with respect to a line normal to the front-face surface plane of the specimen.

Figure 62. Ultrasonic backscattering curve of FP/Mg specimen with nonuniform fiber distribution (Specimen 6-2).

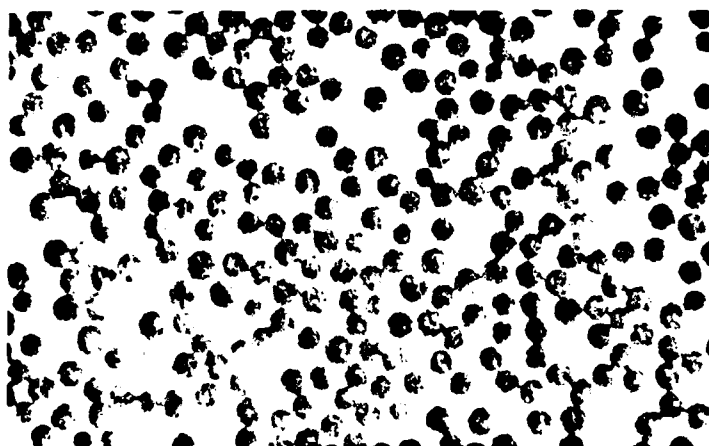
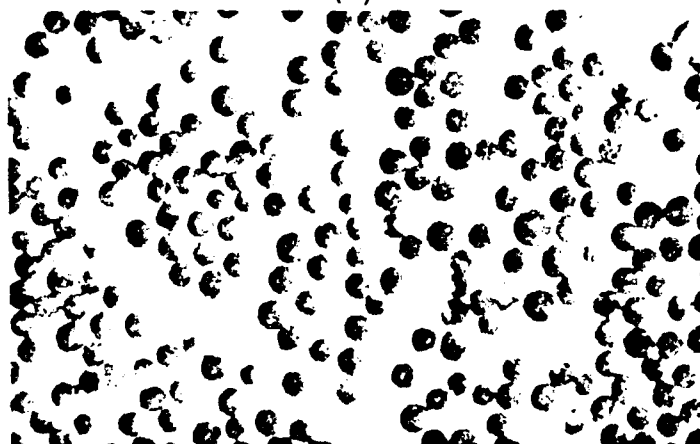
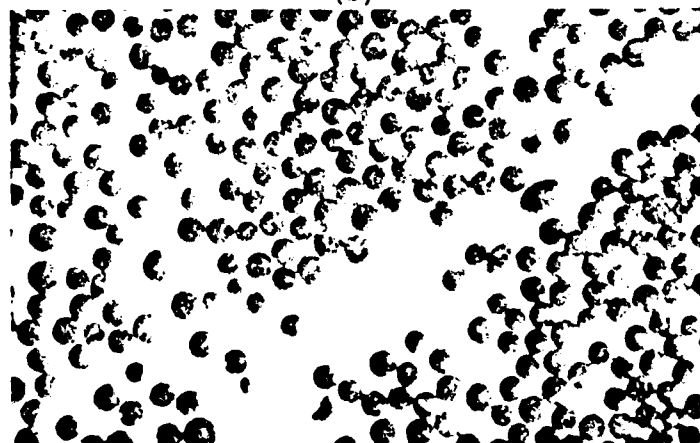
At 200X, the area of nonuniform fiber distribution is apparent in Figure 64b when compared with Figures 64a and 64c. The micrographs shown as Figures 64a and 64c were taken at sections cut through inspection locations 1 and 4 as shown in Figure 60. These two locations have no intentional flaws or defects. Figures 64a and 64c are very similar to the micrographs shown in Figure 28 for Specimen 1-1 (no intentional flaws) as would be expected. The major difference between the micrograph of the area of nonuniform fiber distribution

Figure 64. Micrographs (200X) of FP/Mg Specimen 6-2 (nonuniform fiber distribution) at three section locations: (a) Location 6-2-1, (b) Location 6-2-2, and (c) Location 6-2-3.

(Figure 64b) and the other micrographs (Figures 64a and 64c) is that there is a greater percentage of the matrix visible. This is exactly what was expected since the area of nonuniform fiber distribution was created by removing two fiber plies from the laminate in the circular area indicated in the C-scans (Figures 57 and 58).

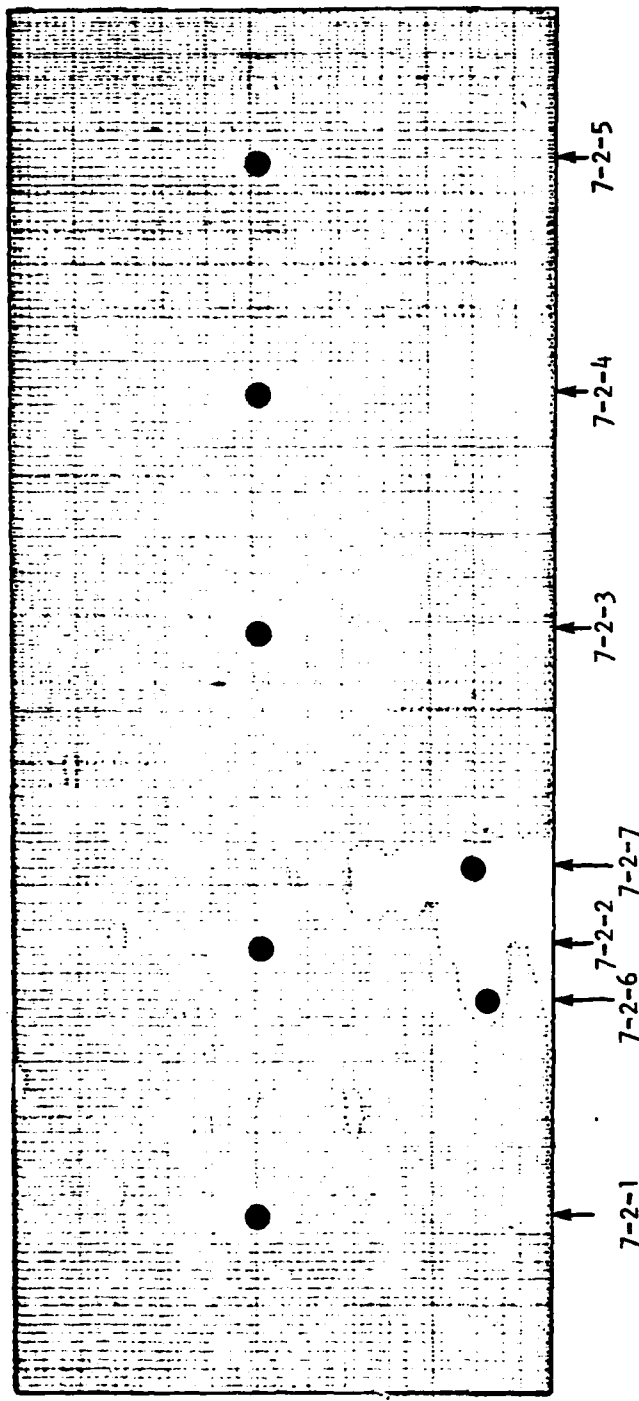
Both C-scans give a clear indication of the presence of a flawed area within Specimen 7-2. The C-scans agree very well with respect to the location and extent of the flawed area. Figure 67 shows an A-scan photograph at an unflawed location (Figure 67a) and within the area of apparent matrix fracture (Figure 67b). Figure 67a is a typical A-scan of a location of unflawed FP/Mg material. There is a well-defined front and back-face reflection which is, once again, very similar to the A-scan (Figure 22a) of Specimen 1-1 with no intentional flaws.

Figure 65. Pen-lift C-scan of FP/Mg Specimen 7-2 (matrix fracture), 5 MHz transducer in pulse-echo mode.

The wave propagation velocities for inspection locations 7-2-6 and 7-2-7 are noticeably lower than those mentioned above. This indicates that the flawed area, shown in Figures 65 and 66, is modestly wave energy dissipative.. This corresponds well with the conclusions drawn from ultrasonic inspection.
